TECH TIPS

Unit starts and runs from ground controls but will not engage starter at platform controls.

Z80,S125,Z135

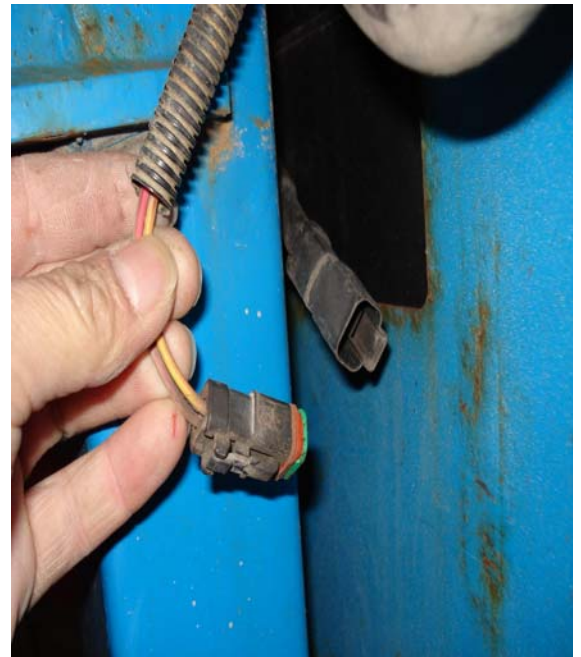
Step 2

Unplug the foot switch and press the engine start button. If unit starts and runs, repair or replace the foot switch.

If unit does not start, proceed to step 3.

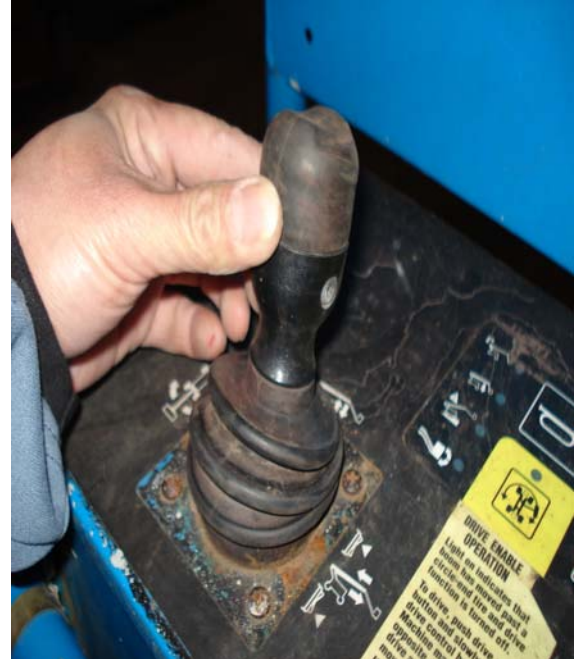
Step 3

Note: Perform this step while wearing a full body harness.

Plug the foot switch back in and engage the foot switch.
Engage the Primary Boom up joystick without enabling the auxiliary button.

If the Primary Boom starts to raise then the auxiliary button is defective and the touch pad needs to be replaced.

If the unit still fails to start after the touch pad is replaced then contact the AWP Service Dept. at 1800-536-1800.
