TECH TIPS

**One or more of the outriggers
will not retract, but will extend.**

TZ34/20 & TZ50/30

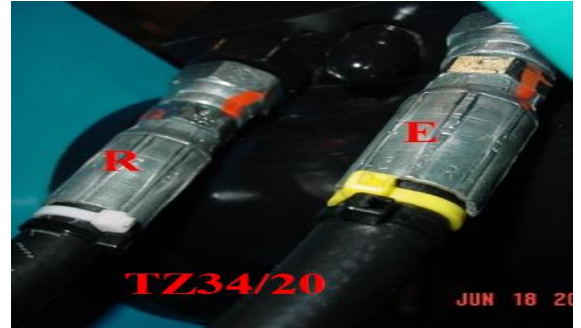
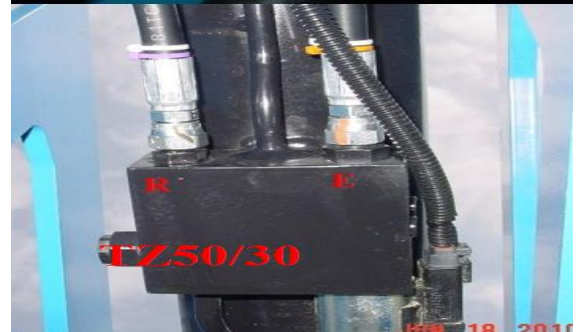
Step 1

The affected outrigger will extend but not retract, and it has already been determined this is not the result of an electrical malfunction.

- Remove the return line from the hydraulic cylinder.

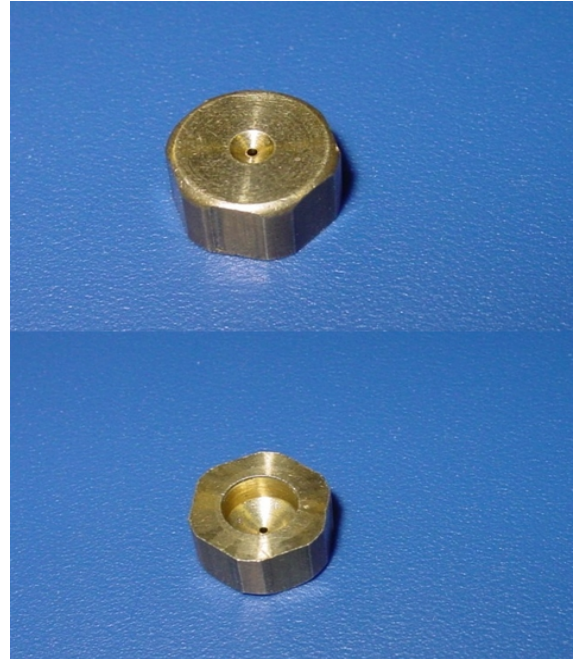
Step 3

Under the black fitting is the combination check valve orifice, (the brass button pictured at right). Remove the orifice from the well under the fitting and clean out the center orifice. Be sure when re-installing the check valve, that the flat face is towards the hose.

Perform a function test and return machine the to service.
